123-TCP Treatment Pilot Project for Domestic Well Households in Northern Monterey County

**Final Report
June 2023**

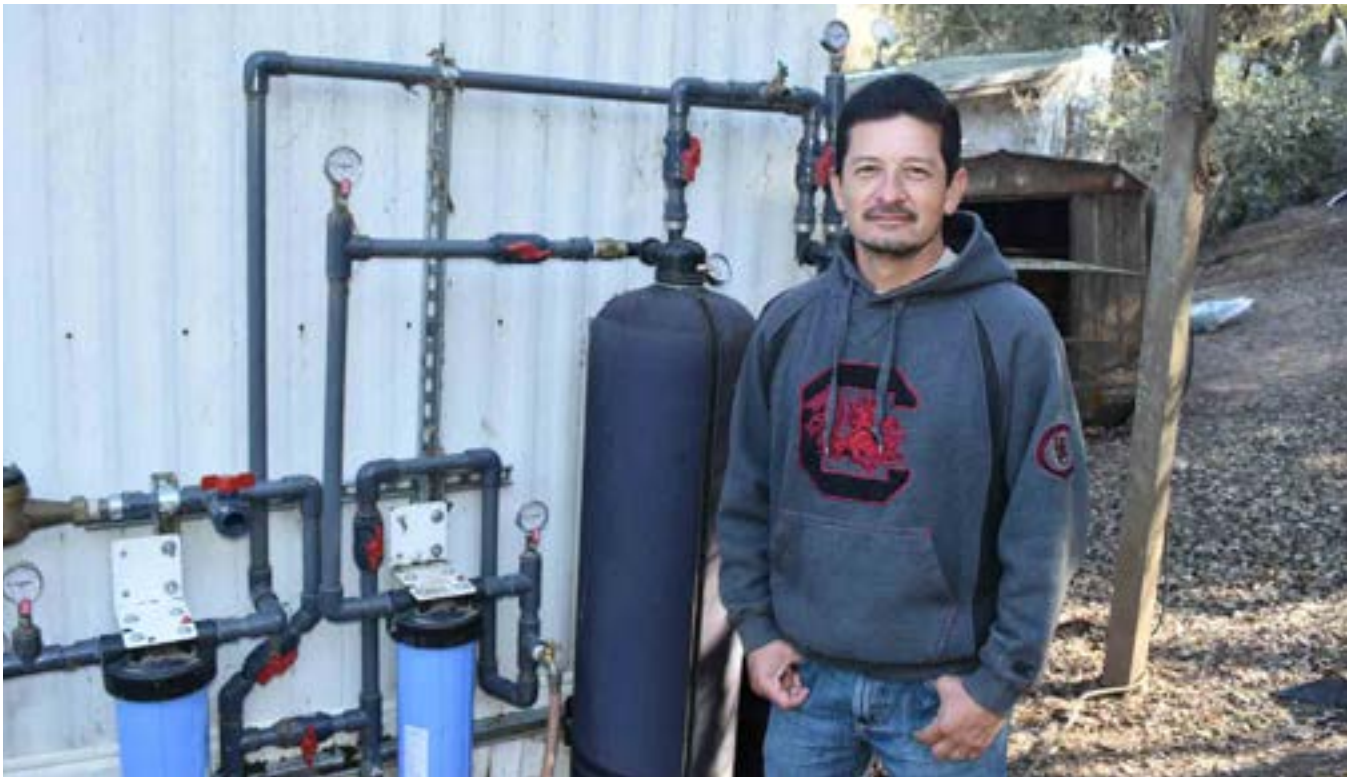
Community Leader Roberto Ramirez next to his 7.2-cubic foot system, DWMC-14 in Royal Oaks.

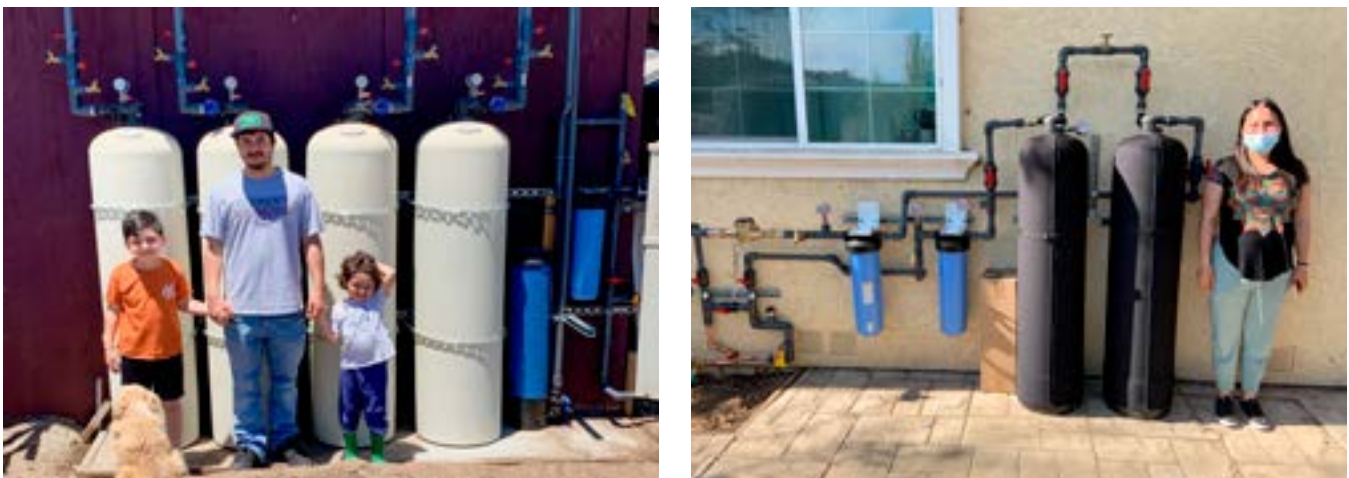
Figure 1: Project participants in front of a 24-cubic foot system (DWMC-09) near Salinas (left), and a CWC staff member next to a 7.2-cubic foot system, DWMC-19 in Royal Oaks (right).

123-TCP is removed from the drinking water using granular activated carbon (GAC)⁵. Water passes through tanks containing carbon, and 123-TCP attaches to the carbon granules. The water passes through two tanks during treatment, a lead tank and a lag tank. Over time, the carbon becomes saturated with 123-TCP and is no longer able to remove the contaminant. Once this happens, the lag tank is moved into the lead position, and the GAC in the lead tank is replaced, ensuring no 123-TCP passes out of the treatment system to the home. More treatment system design details can be found in Appendix D.

Photos of the 123-TCP treatment systems are shown below in **Figure 1**.
