**COMMUNITY WATER CENTER**  
EL CENTRO COMUNITARIO POR EL AGUA

## 123-TCP Treatment Pilot Project for Domestic Well Households in Northern Monterey County

# Appendices

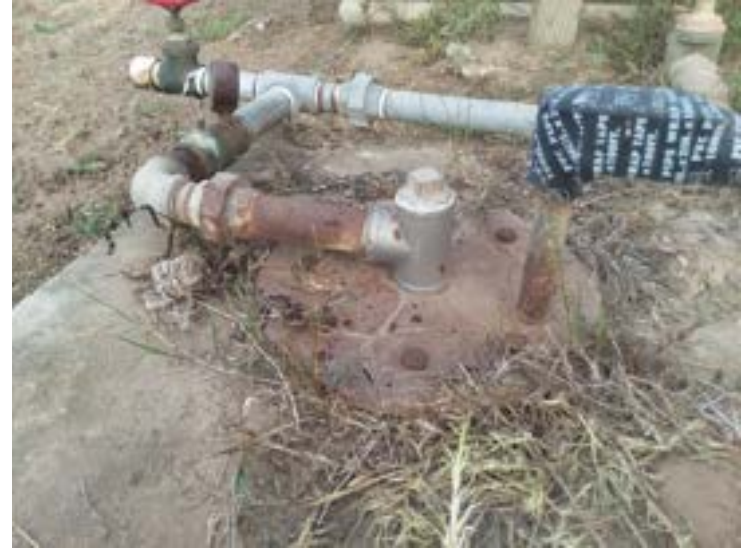
Cracked well seal at potential pilot project location. Photo by Weber Hayes and Associates.

Heather shared a photo of a cracked well seal at a potential pilot project location where the well also tested positive for total coliform bacteria. This well was one of the three wells where site assessments have been completed. In addition, at least one potential project participant does not have access to the well on their property (they own the land and lease it to a grower that restricts access to the well). Property owners have also raised questions and concerns regarding possible property modifications, the size and appearance of the treatment systems, and have requested to have the option to uninstall the system at the end of the project if they are unable to afford operation and maintenance costs. Another project finding so far is that some households will require additional plumbing in order to separate water used indoors from water used outdoors (some houses are plumbed such that irrigation/outdoor water first enters the household). This may result in an additional project cost.

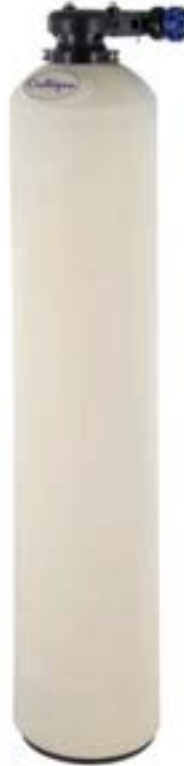
Quadra-Hull® tank (shown) includes sweat jacket to prevent condensation on tank exterior.

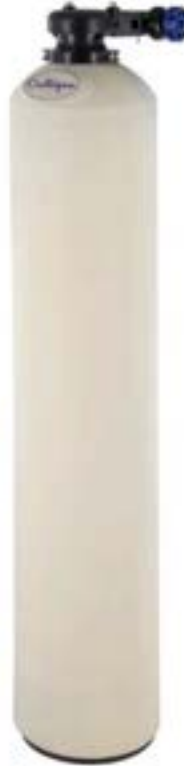
Quadra-Hull® tank (downflow) includes sweat jacket to prevent condensation on tank exterior.

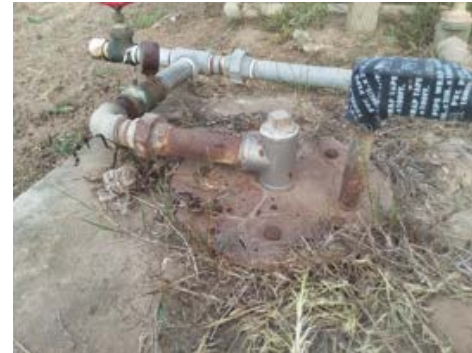
Cracked well seal at potential pilot project location. Photo by Weber Hayes and Associates.

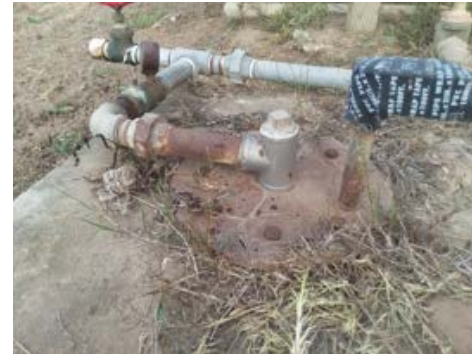
Cracked well seal at potential pilot project location. Photo by Weber Hayes and Associates.

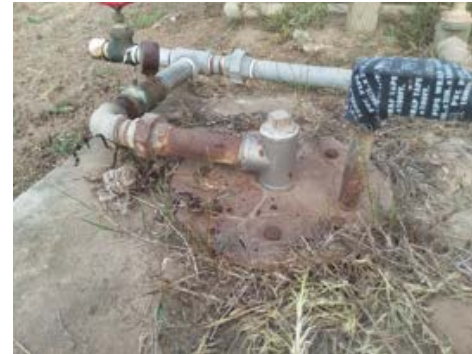
Cracked well seal at potential pilot project location. Photo by Weber Hayes and Associates.

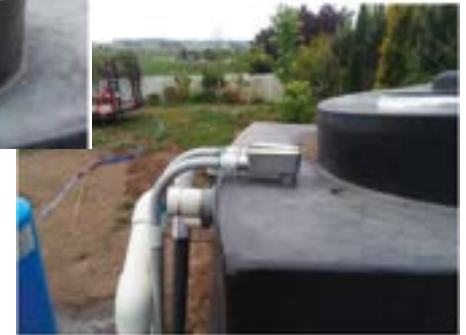
DWMC02 - Replaced Junction Box at Tank for Float Switch and Ozonator

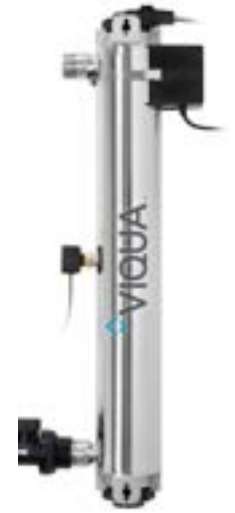
Viqua NSF  
Class A UV  
(~\$2000)

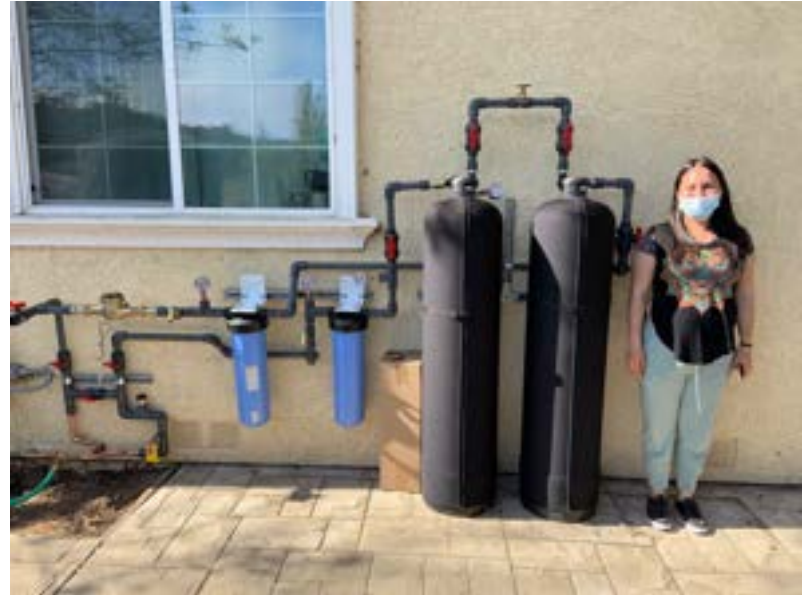
CWC Team Member Shirley Robles pictured next to the Phase 2B treatment system installed at DWMC-19 located near Las Lomas in north Monterey County. This treatment system is the 3.6 cubic foot size.

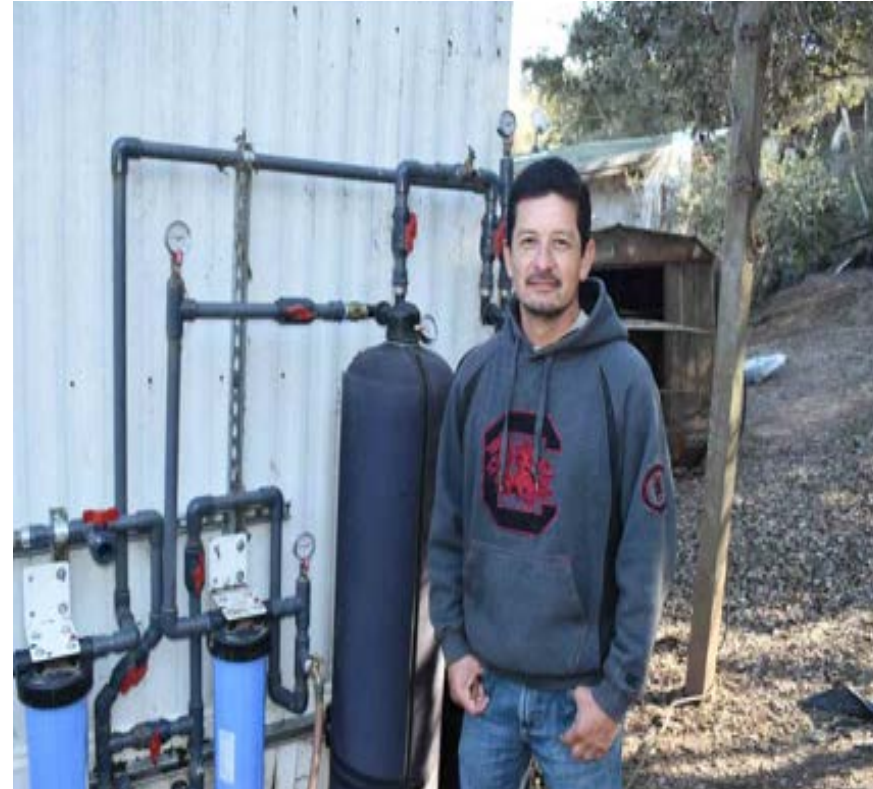
Community Partner Roberto Ramirez pictured next to the Phase 2B treatment system installed at DWMC-14 located near Royal Oaks in north Monterey County. This treatment system is the 3.6 cubic foot size. 12

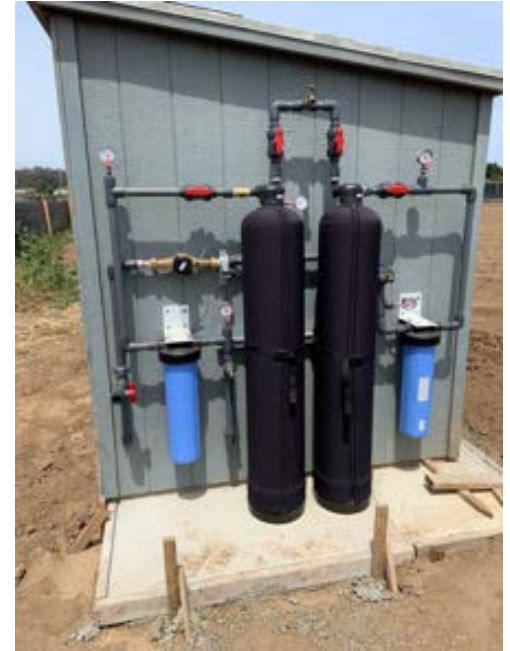
Phase 2B treatment system installed at DWMC-21 located near Moss Landing in north Monterey County.
